EN E:25 error code caused by loose drain pump covers

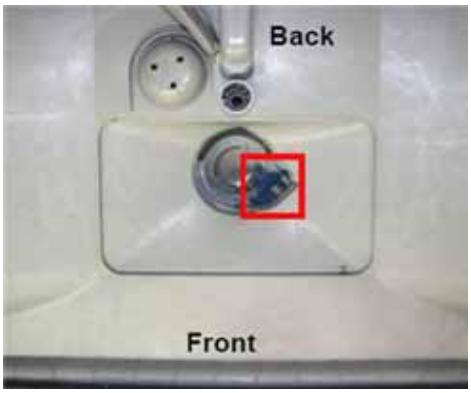
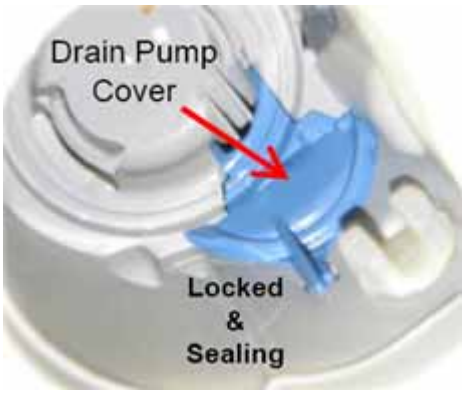
If an Ascenta dishwasher doesn't drain properly and / or shows an **E:25** error code, the problem could be the drain pump cover wasn't replaced properly (i.e. not completely seated and locked into position). Loose drain pump covers allow more water flow to the drain pump, increasing the pump load, drawing more current and causing an **E:25** error code.

The ***Clean*** light can come on, giving the impression the dishwasher finished it's cycle when it actually didn't.

Occasionally **E:23** and **E:24** error codes can occur as well.

Drain pumps and controls have been replaced, causing unnecessary part orders and returns.

Repair:

- Remove cover.
- Check for damage. Clean out any debris.
- Replace cover, making sure cover solidly locks into place.
