Information Document

Affected Bosch Appliances

BSH Home Appliances Ltd is conducting a voluntary safety campaign regarding two models of built-in gas hobs. The reason is potential damage to installed gas connectors. In certain circumstances, gas can escape in an uncontrolled manner and in extremely rare cases a risk of explosion can arise.

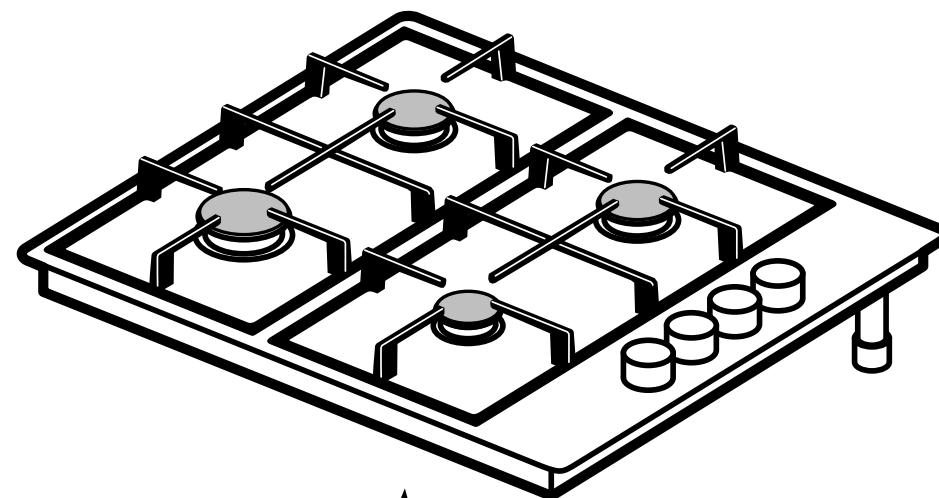
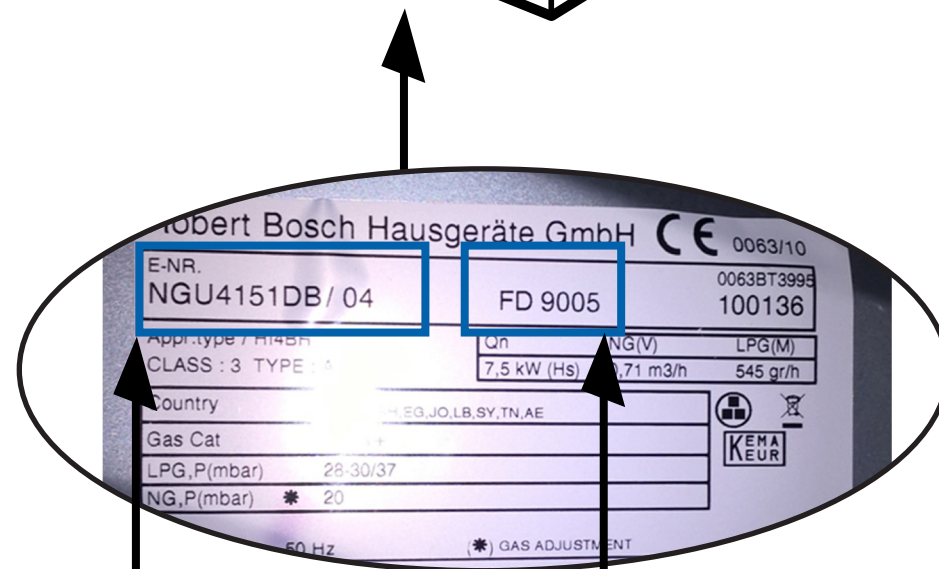
The appliance E.Nr number and FD number can be found on the original user manual. This can be found on the front or rear of the manual.

Alternatively the E.Nr number and FD number can be found on the Rating Plate of the appliance. This is located on the underside of the hob.

A model is affected if the E.Nr number is NGU4151DB, and the FD number is in range 8901-9110.

E.Nr Number

FD Number

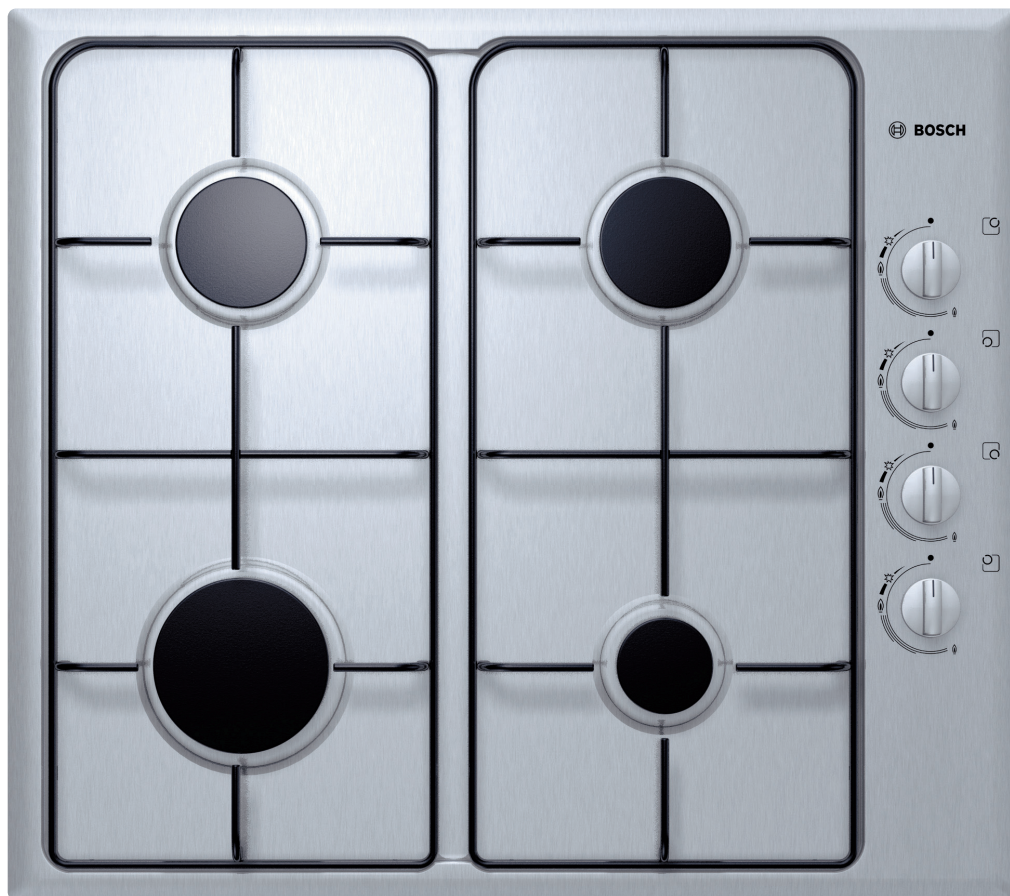
Appliance Size

Potentially affected models are 60cm wide with a stainless steel top **only**.

Hobs with other coloured tops are not affected.

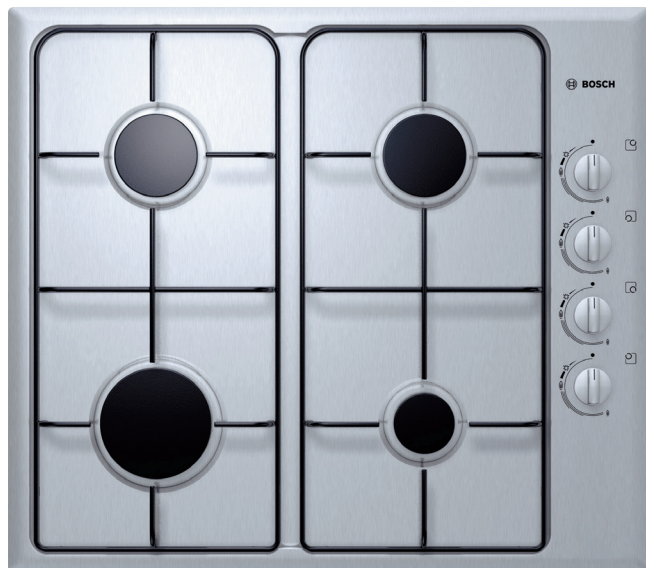
This appliance is **possibly affected** as controls are on the **right side**.

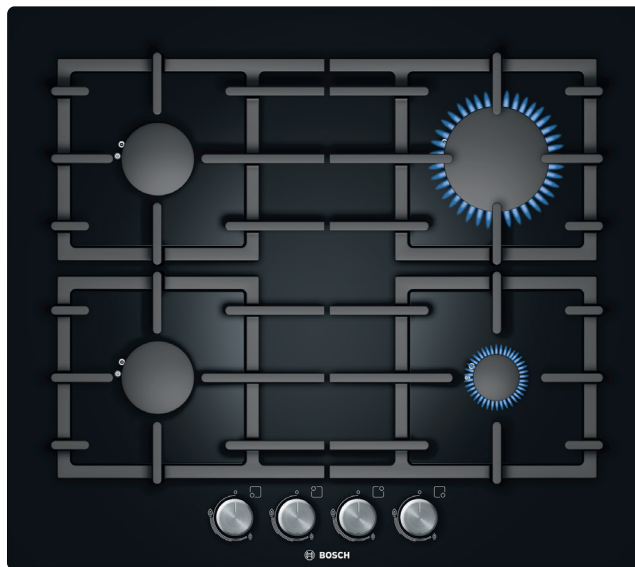
This appliance is **not affected** as the controls are on the **front**.

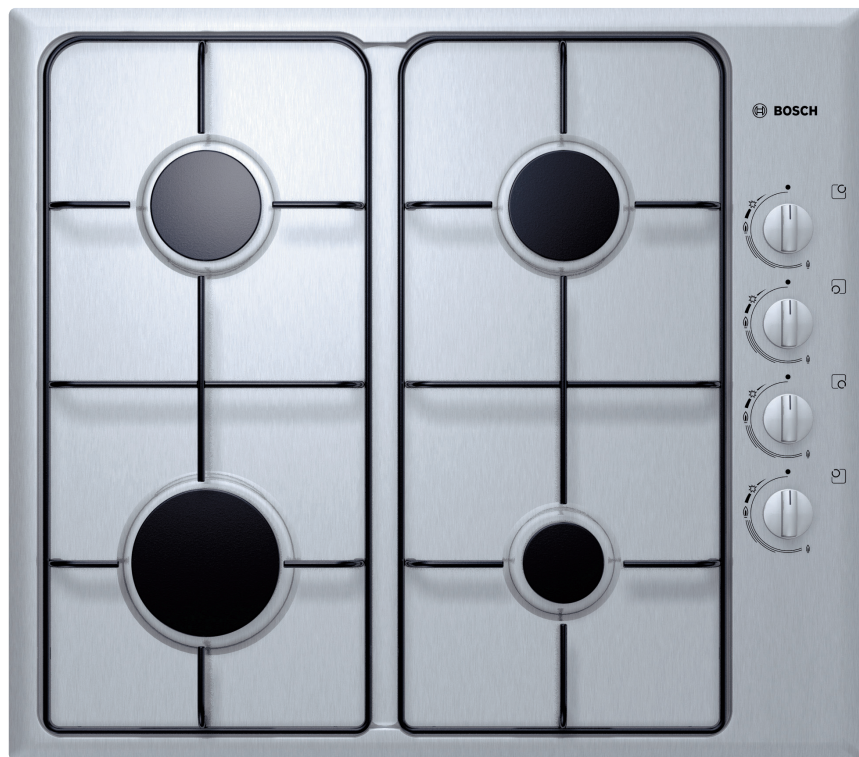
Possible **affected** models have 4 standard single flame burners.

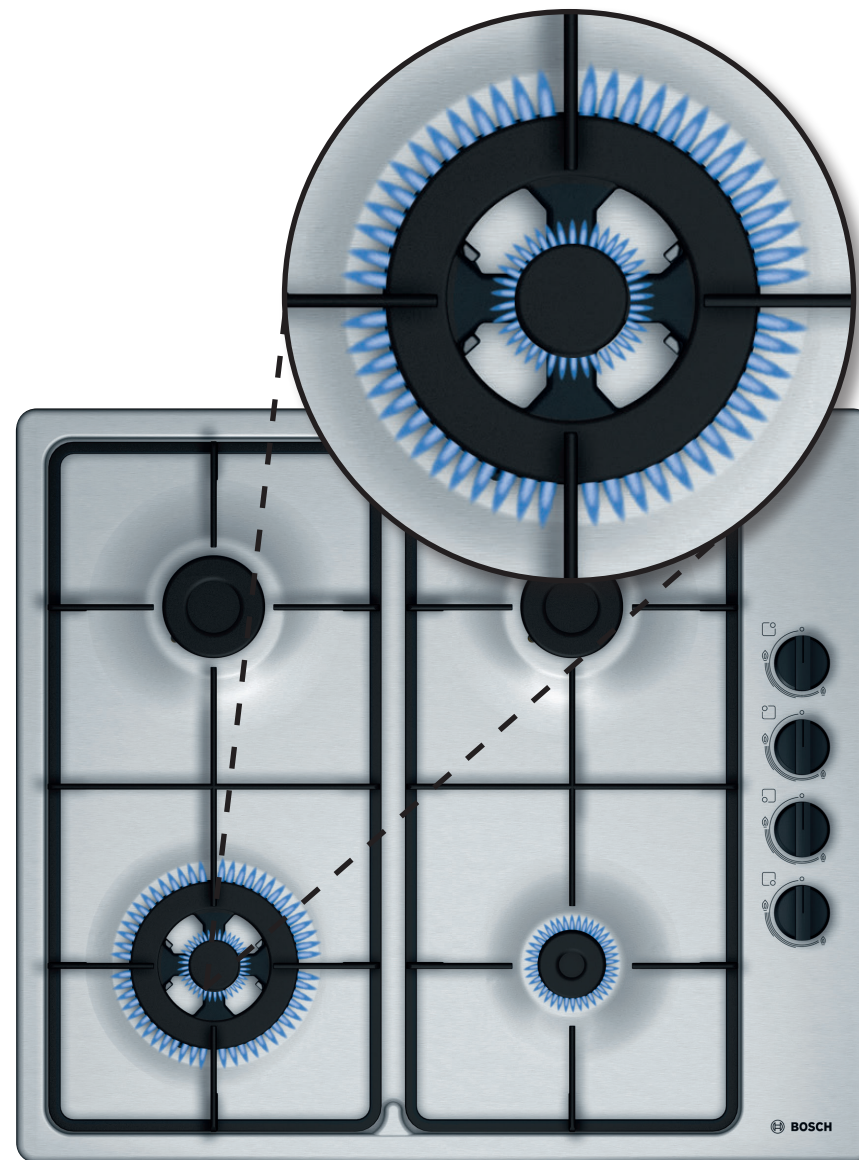
Models with dual flame wok-style burner are **not affected**.

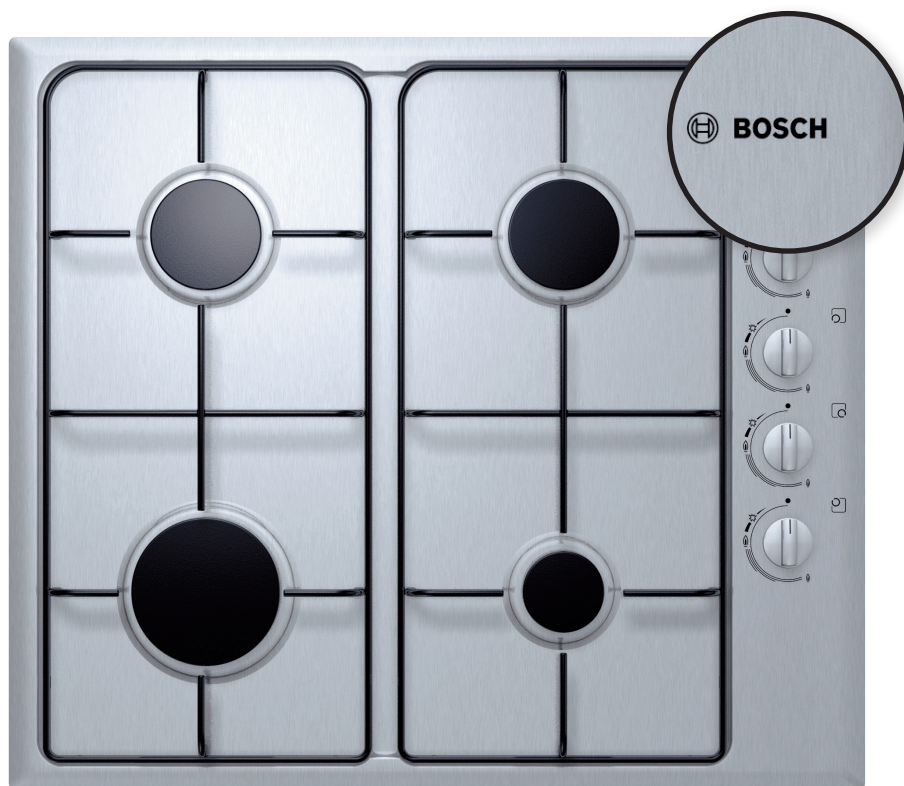
An appliance is **possibly affected** if the **logo** is situated in the **top right hand corner** and the logo is printed in black.

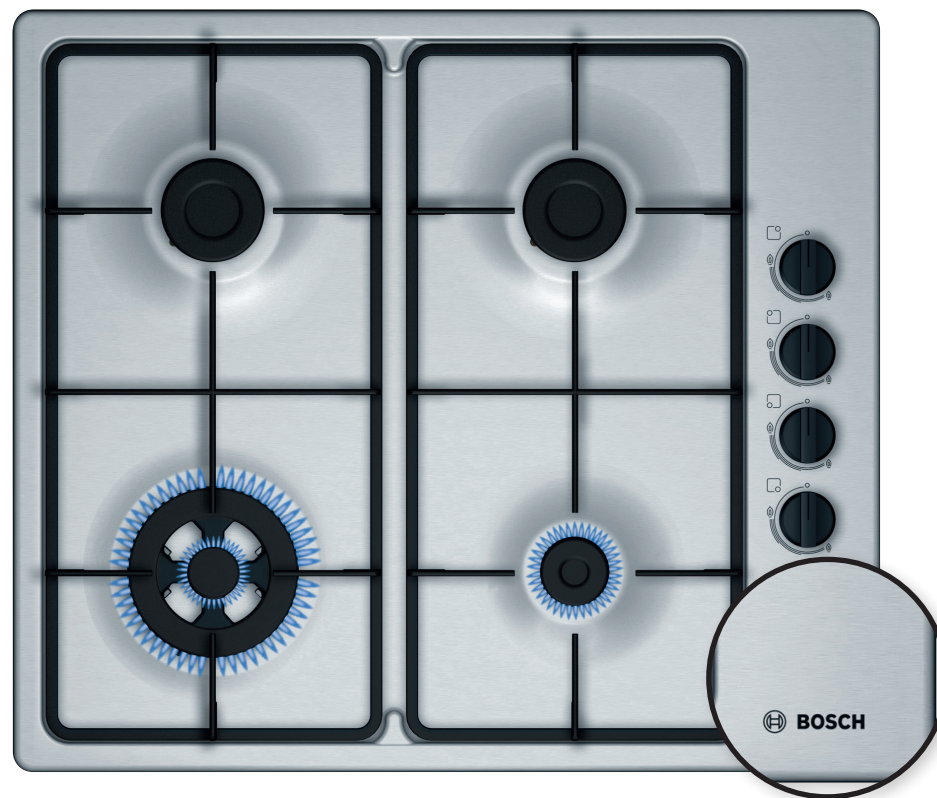
An appliance is **not affected** if the **logo** is either engraved or situated on the **bottom right corner**.

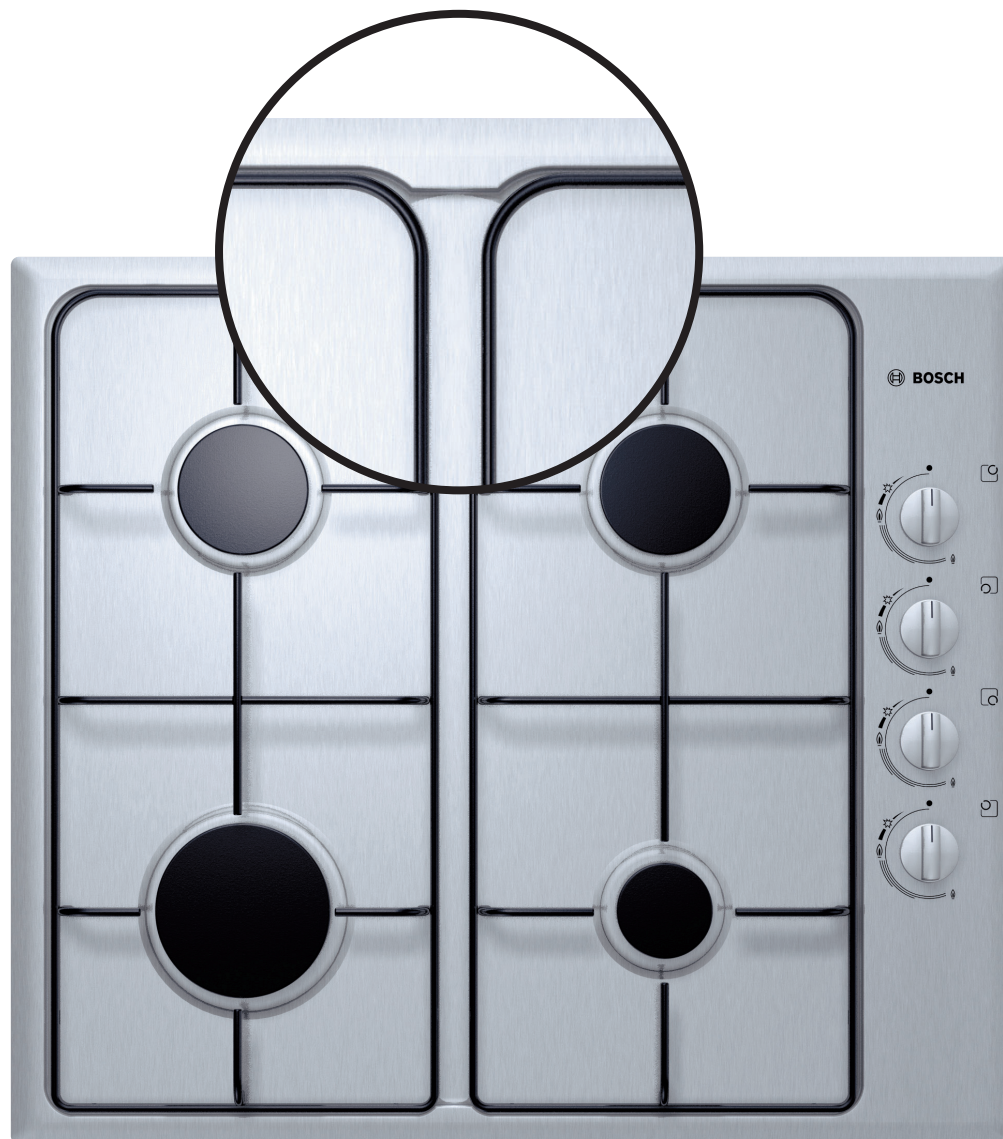
Distinctive pan supports – combination of:

1. Thin gloss black coated pan supports
2. Specific left and right hand location:
 - Distinctive rounded corners at the rear
 - Squarer corners at the front
3. Pan supports cannot be rotated 180°.
(Non-rotational)

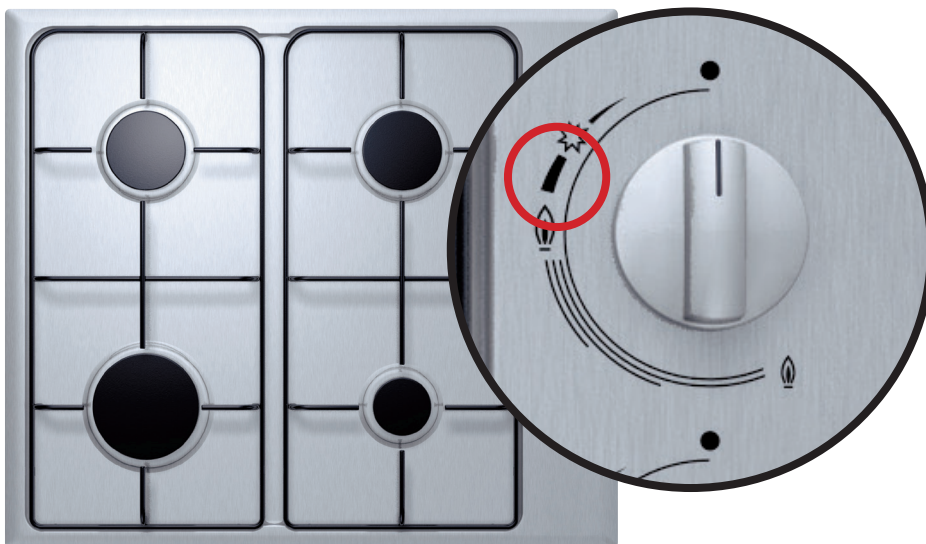
Printing in and around the ignition position is unique to this appliance with solid tapering black lines.

Appliances with the **solid tapering black line** are **possibly affected**.

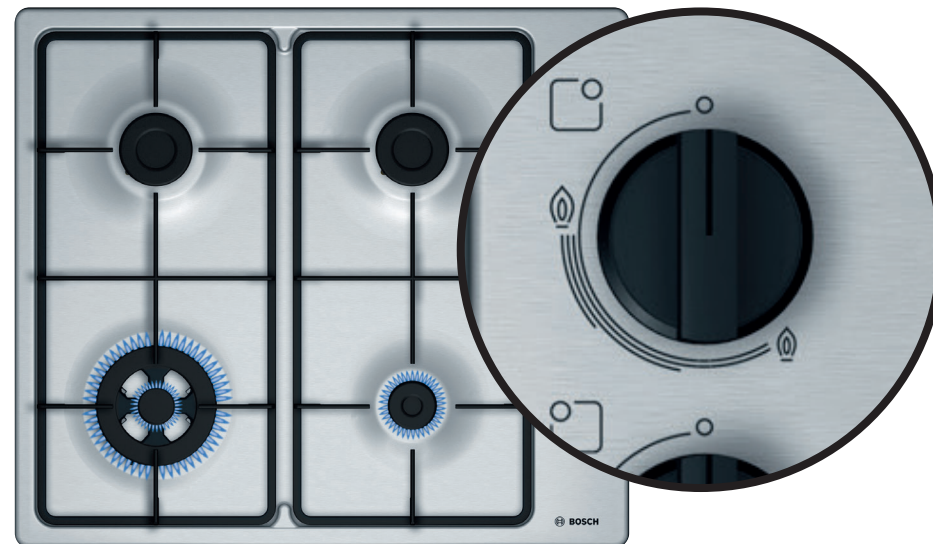
Appliances with the following features are not affected.

1. Printing in and around the ignition position has a simple single line
2. Printing in and around the ignition position is pressed into the metal – not printed in black
